# Creating Value with NDT for Corrosion under Insulation (CUI)

Effective assessment through proper CUI recognition and mitigation available at TÜV Rheinland

# Creating Value with NDT Methodology for Corrosion Assessment under Insulation

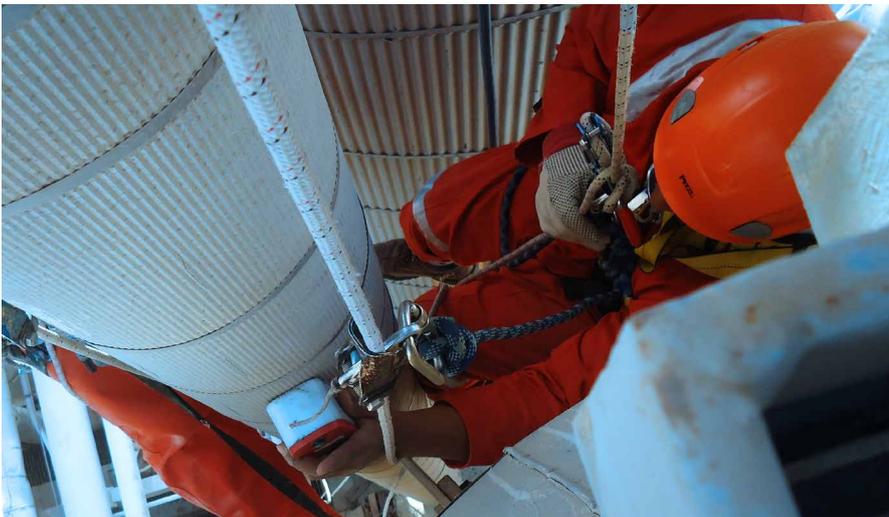
Fig. 1. PEC CUI examination of a vertical pipe using rope access operator to cut down scaffolding costs and reduce preparation time to access the object

PEC equipment is based on electromagnetism and helps effectively determine the average wall thickness (AWT) of low-alloyed carbon steel components through their insulation, enabling the detection and localization of CUI. PEC is successfully used in the industry for detection and semi-quantitative sizing of CUI. The main advantage of PEC is its ability to ascertain general wall thinning in insulated

objects without removing the insulation and without any object surface preparation. The technology is characterized by its extensive penetration depth and relatively low sensibility to lift-off. PEC is a complementary solution to other NDT solutions for CUI and has been used in a number of different applications, including the detection and measurement of corrosion under fire-proofing (CUF) in skirts of process columns, in the support legs of spherical storage tanks, and on various types of insulated pipes and vessels in on- and offshore installations. Most of these objects are insulated and water ingress may cause corrosion underneath the covering. The deterioration process cannot be seen from the outside. Using PEC to indicate the affected areas can lead to significant cost reduction, especially because this non-intrusive inspection method may be applied on stream and far before a turnaround has to be performed. This approach assists the prioritization and efficient planning of all related turnaround activities helping reduce risks, shorten task duration and minimize installation downtime. Companies like Shell also rely on this technology for CUI protection and assessment programs.

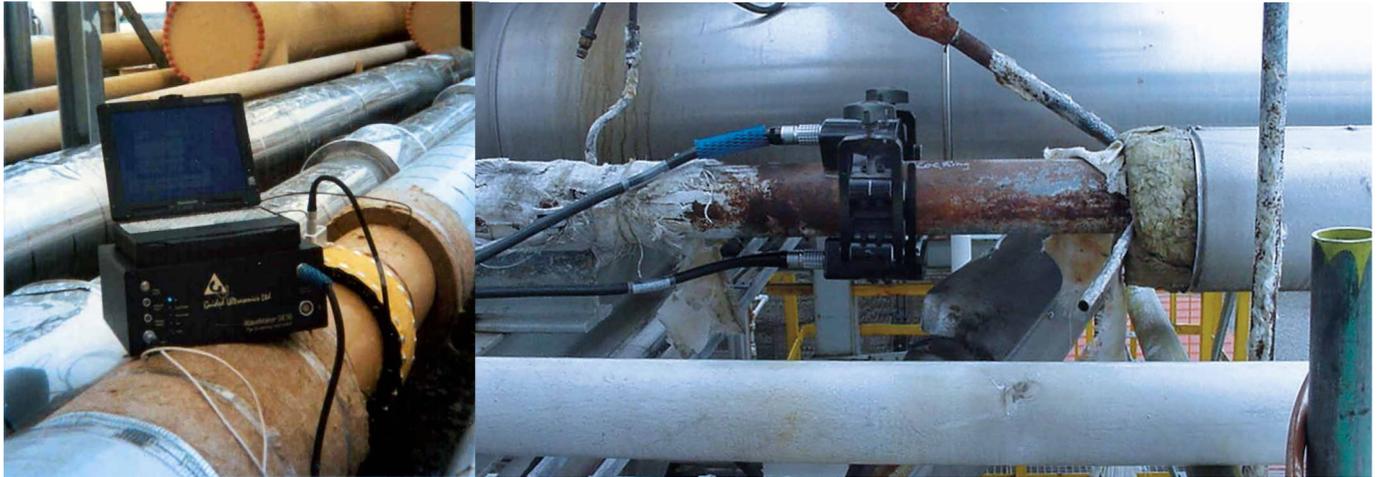
Fig. 3: Guided wave technology applied on pipe racks

Guided waves measurement is one of the key complementary technologies for the assessment of corrosion under insulation for long lengths of pipe. Typically, it uses low-frequency guided ultrasonic waves that propagate along the pipe wall and can detect external or internal corrosion. The technology requires insulation be removed, however, only in a very small circumferential location. This part is used to attach the ring with the ultrasonic sensors onto the pipe. This way, long and difficult to access pipes can be examined from a single location with minimal preparation and

Our guided waves technology is often used to assess CUI on sleeved road crossings, buried pipe, wall penetrations, pipe racks, corrosion under supports, offshore risers and caissons, previously unrecorded weld locations, subsea lines and similar.

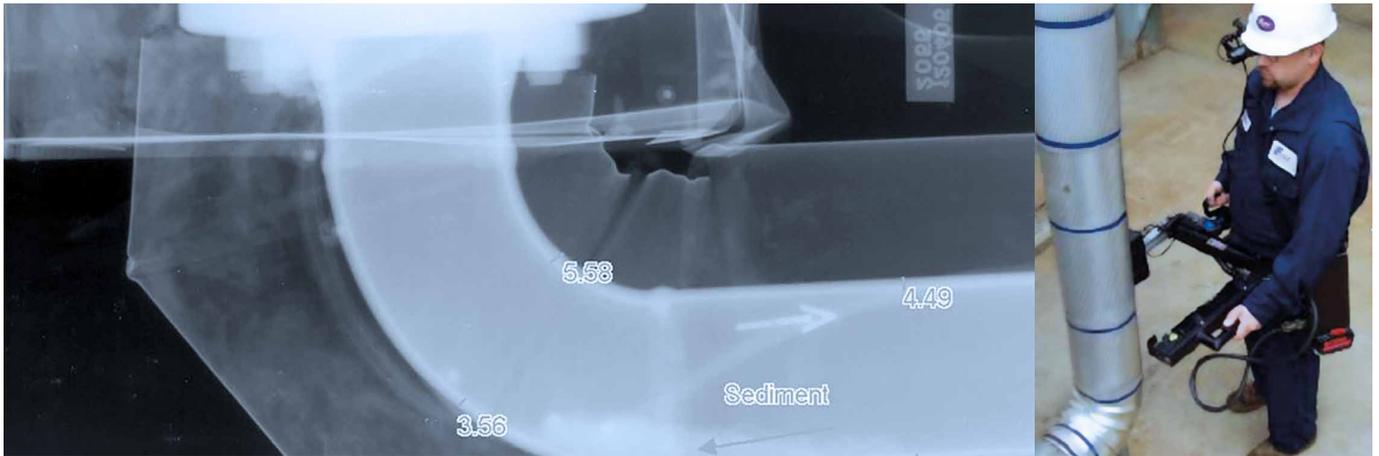
Fig 4: Digital radiography (right); Real time video profilometry (left)

This technology makes use of a radiation source and an X-ray detector (often a linear array of radiation detectors). These are positioned in such a way that an on-stream X-ray inspection can be conducted, resulting in real-time imaging of potential anomalies under the insulation. With this technology, both internal and external corrosion defects on stretches of pipe can be detected while the pipe remains in service and without removing any insulation. As the unit and/or scanner are positioned onto the pipe, X-ray data is acquired and displayed on the monitor in real time. Straight piping segments as well as locations with bends and elbows can be inspected using this technology. The system is sensitive enough to detect corrosion defects as small as 0.25 inch in diameter and 0.05 inch deep.

Most recently newer lightweight digital X-ray technologies have been introduced to the market. These systems are characterized by extremely low radiation levels and only a very small area of operation has to be cordoned off to carry out the procedure as compared with conventional radiography techniques. Operations can continue with minimal disruption to ongoing adjacent activities. These newer units project real-time digital X-ray images onto a handheld LCD and head-mounted display. The imager itself is highly sensitive, minimizing required levels of X-ray energy. This ensures that this tool is safe to hold. Rapid in-motion scanning of pipes with a range of material densities allows for continuous imaging. These include carbon/stainless steel, cast iron products, aluminum, plastics and composite materials.

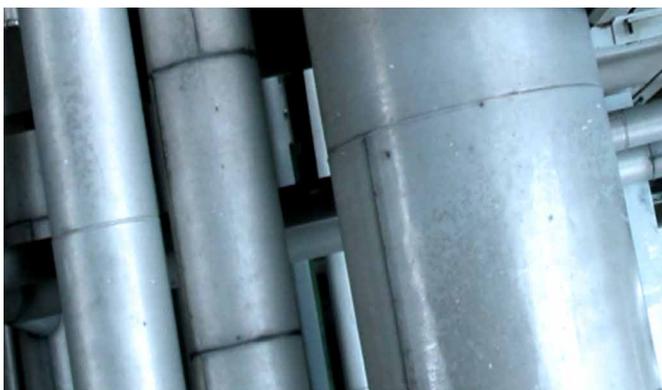
Fig. 5: Insulated pipes

Visual examination is an effective method for locating CUI and it helps identify potential CUI hazards resulting from damaged weather proofing, cladding and/or insulation layers. Weather proofing protection in the form of cladding dents, sealing, junctions and overlapping are potential penetration points for (rain)water, therefore this “barrier” needs to be monitored for effectiveness.

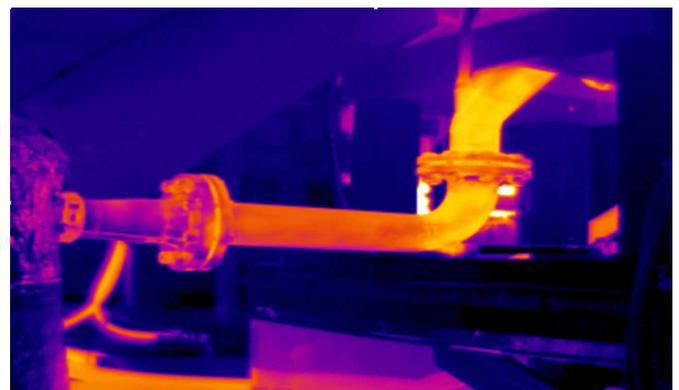
Fig 6: Object temperature, insulation quality condition and energy waste shown using thermography

Thermography and thermal imaging has been successfully used in the petrochemical industry for inspecting and monitoring system performance as well as the integrity of insulated pipelines and vessels for many years. Thermal imaging easily shows temperatures of materials and objects, and it is an effective method for the detection of energy waste. It therefore contributes to determine the insulation quality condition. Thermography can help locate water penetration and even leakages and any anomalies in insulation performance.
